PRE-CONSTRUCT ARCHAEOLOGY

## A NEW MILLENNIUM AT SOUTHWARK CATHEDRAL

INVESTIGATIONS INTO THE FIRST TWO THOUSAND YEARS

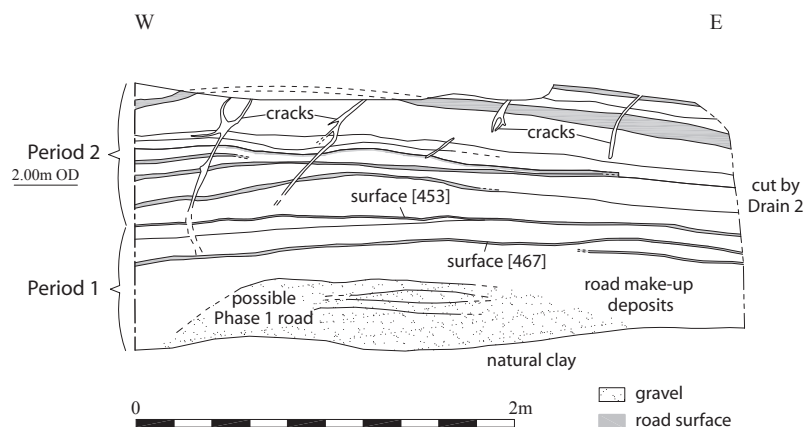
Fig. 8 South facing section through the road as seen in Trench 1; for location see Fig. 9 (scale 1:40)

precursor, as indicated in section (Fig. 8), such as was found at the Bonded Warehouse.

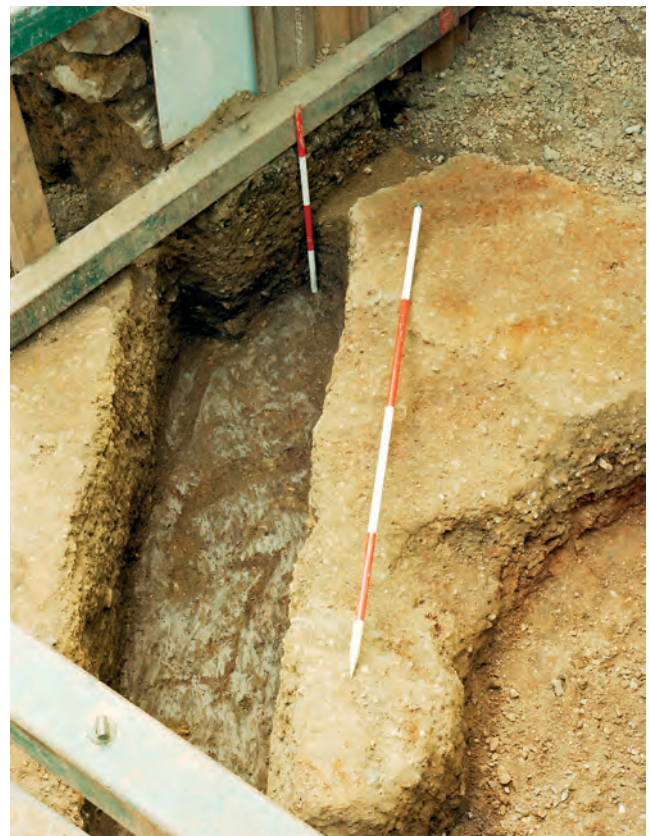
Fig. 15 Drain 1, looking north, showing traces of timber lining

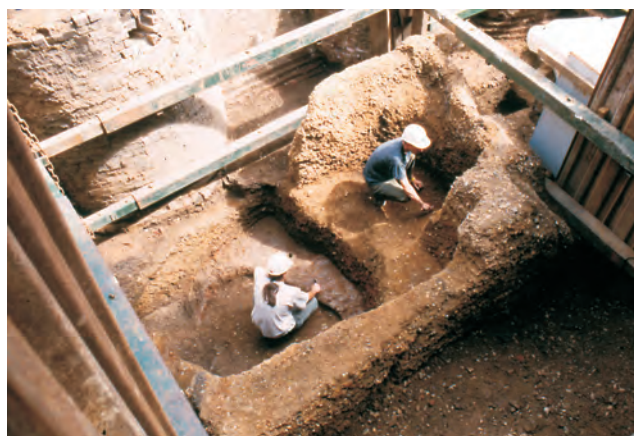
Fig. 17 The road during excavation, showing the severe impact of later intrusions

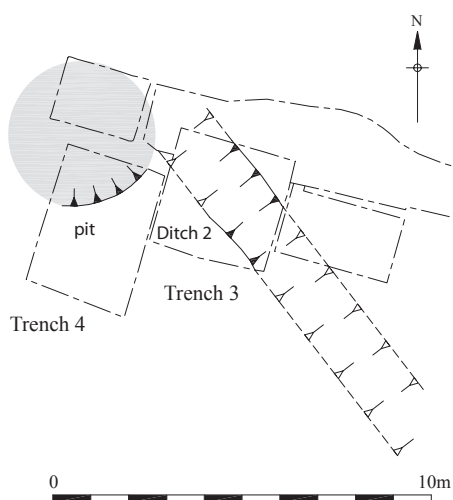
Fig. 22 Ditch 2 and associated pitting (scale 1:200)

A northwest–southeast orientated ditch (Ditch 2), 1.8m wide and 1.22m deep, cut through the gravel surfaces in Trench 3 (Fig. 22). Its lower fills produced early 2nd-century pottery, which may have been residual, while its upper fills produced a mid 2nd-century assemblage including material from the BB2-producing kilns of North Kent, and from the Highgate Wood and Verulamium

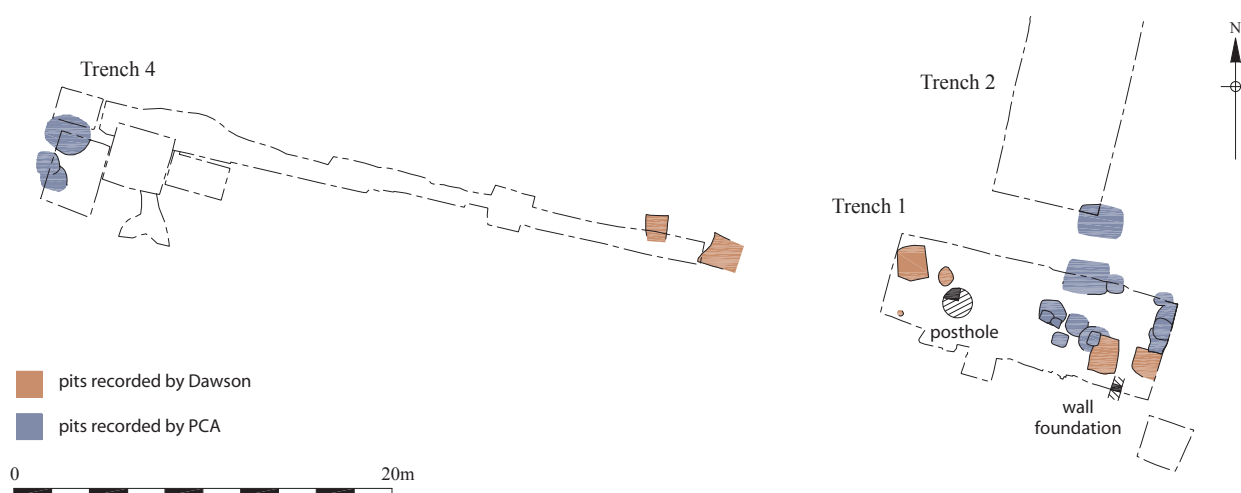
Fig. 26 Saxo-Norman pitting and structural remains (scale 1:400)

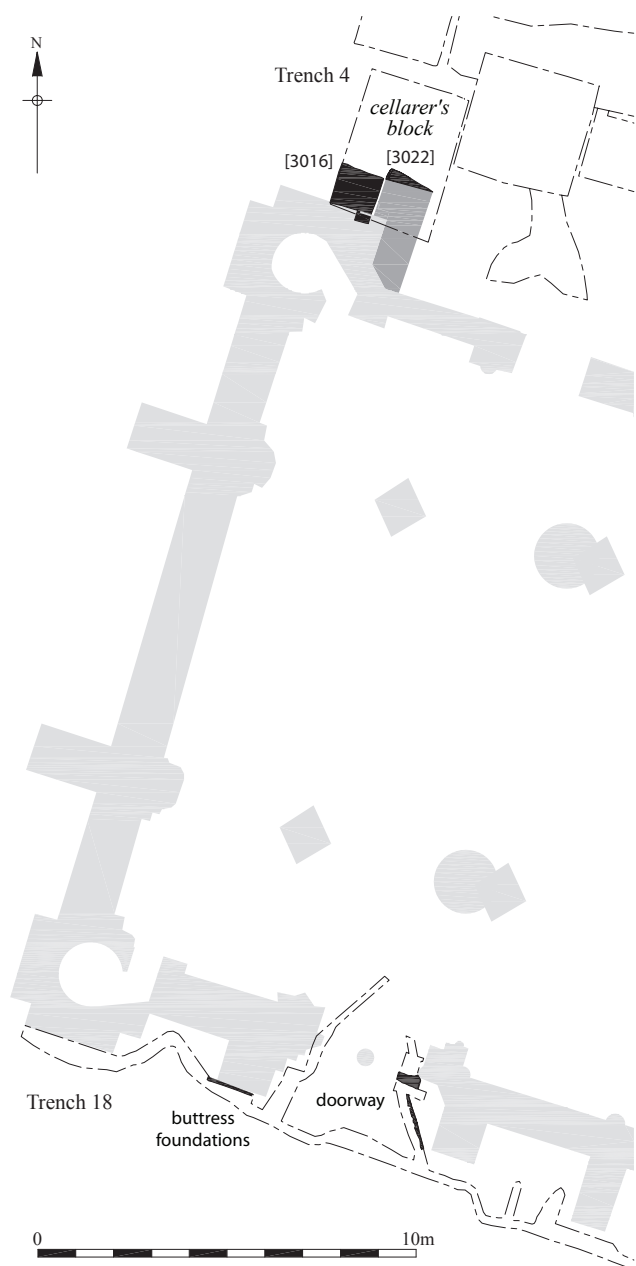
Fig. 33 Details of remains of cellarer's block and southwest doorway (scale 1:200)

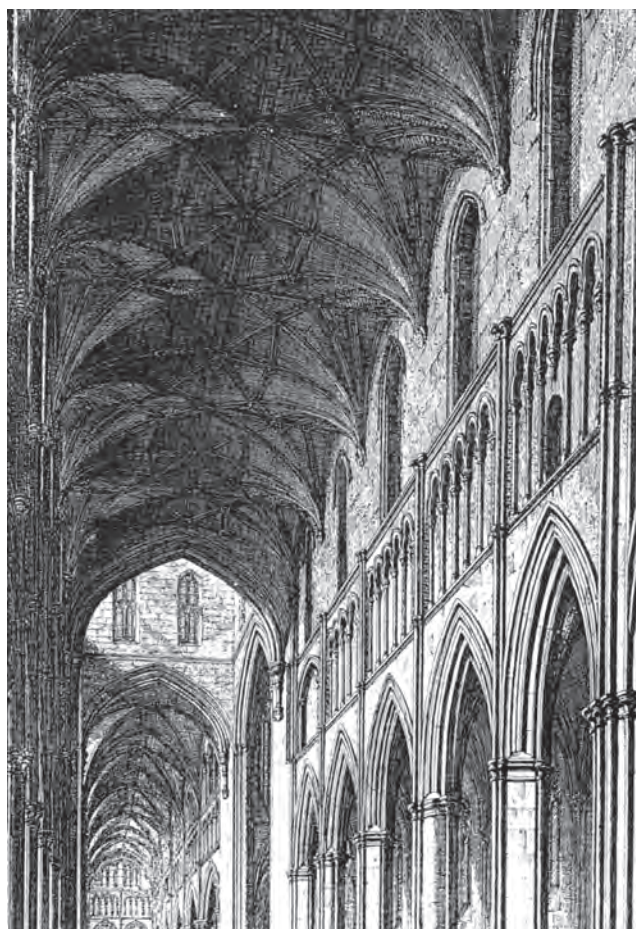
Fig. 34 The easternmost five bays of the timber ceiling *in situ*

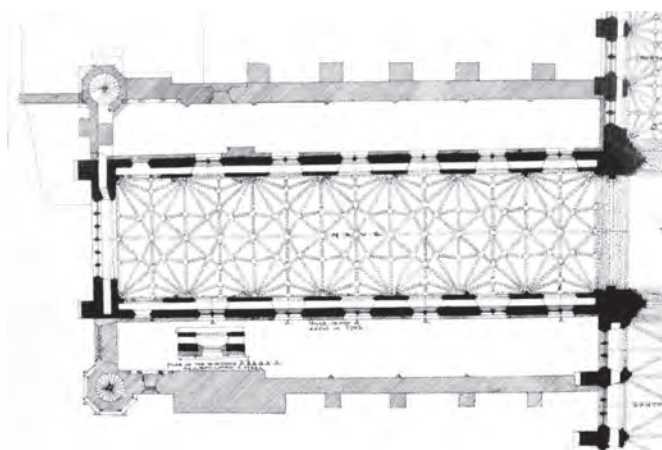
Fig. 35 Plan of the nave ceiling (from Dollman 1881)

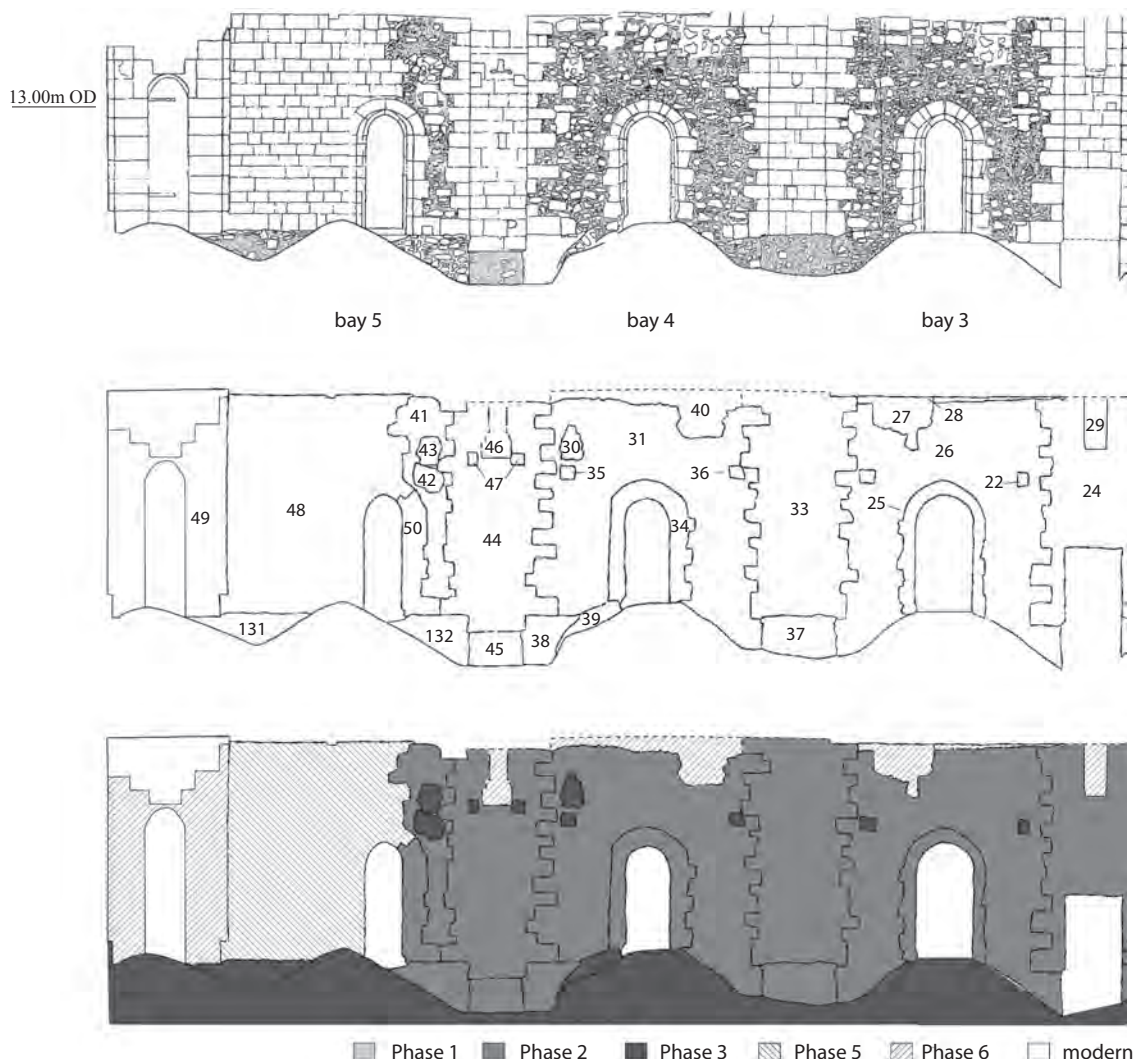
Fig. 39 Elevation of the north choir wall at triforium level (scale 1:100)

The next phase of construction is well represented at triforium level. This includes masonry in Bays 2, 3, 4, 5 and at the east end (Fig. 40, Fig. 41). The walls (12, 26, 31, 41, 52 and 54) are built of a mixture of different stone types and, (with the exception of context 54 which contains squared blocks of Reigate and Caen stone), consist of small, roughly hewn pieces of Reigate, Caen, Ragstone, Mertsham, flint, chalk, with some tile and slate. Fragments of re-used moulded stonework are also visible in places. The masonry is randomly coursed and bonded with a pale pink/buff mortar of variable consistency with frequent chalk and gravel inclusions. On the north side, each bay has a round-headed, single splayed opening (contexts 11, 25, 34 and the remains of the opening in Bay 5 50). Two round-headed apertures are present in the east wall (55 and 58). The mouldings are all of Reigate stone, finely dressed and bonded with a fine white mortar, as are the buttresses

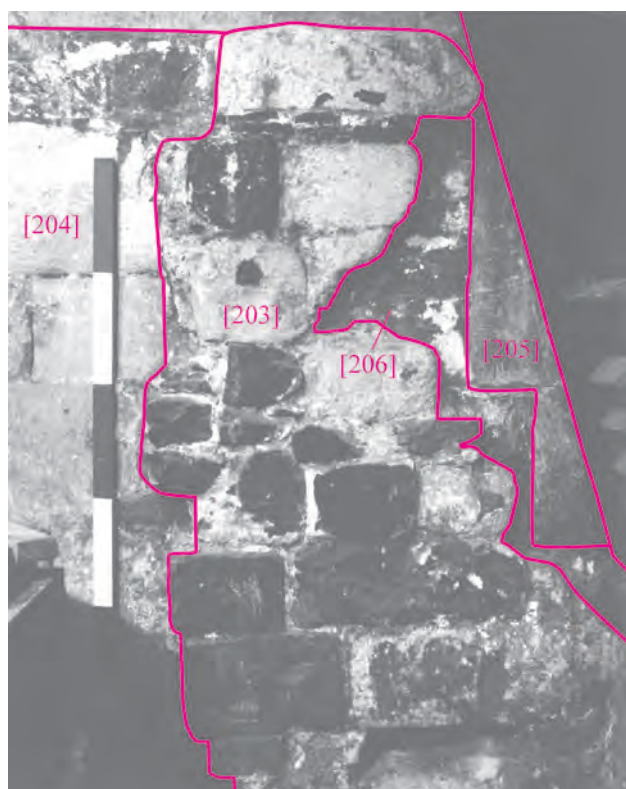
Fig. 44 The 'burnt' fragment of masonry in the north transept (1m scale)

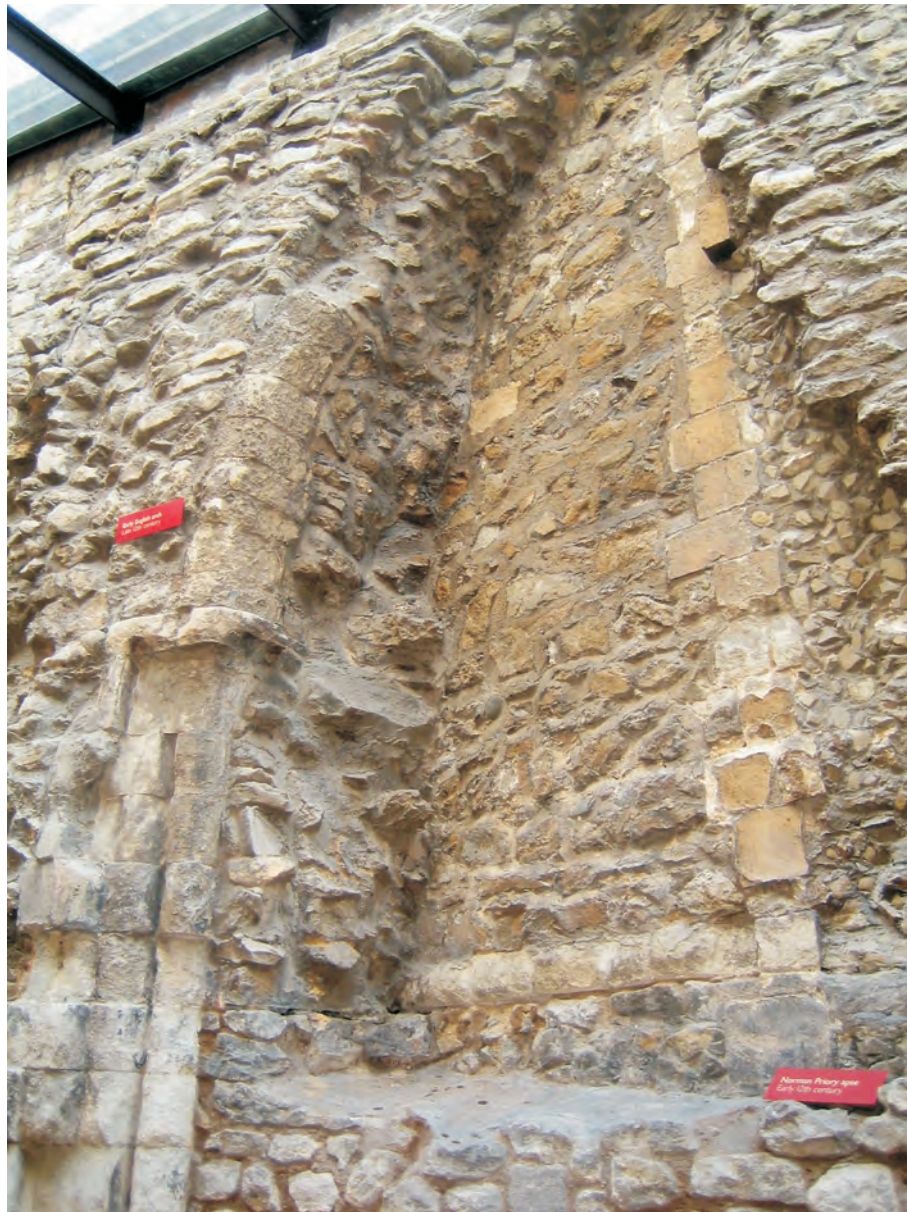
Fig. 46 Medieval elements visible in the external north wall of the Chapel, looking southeast

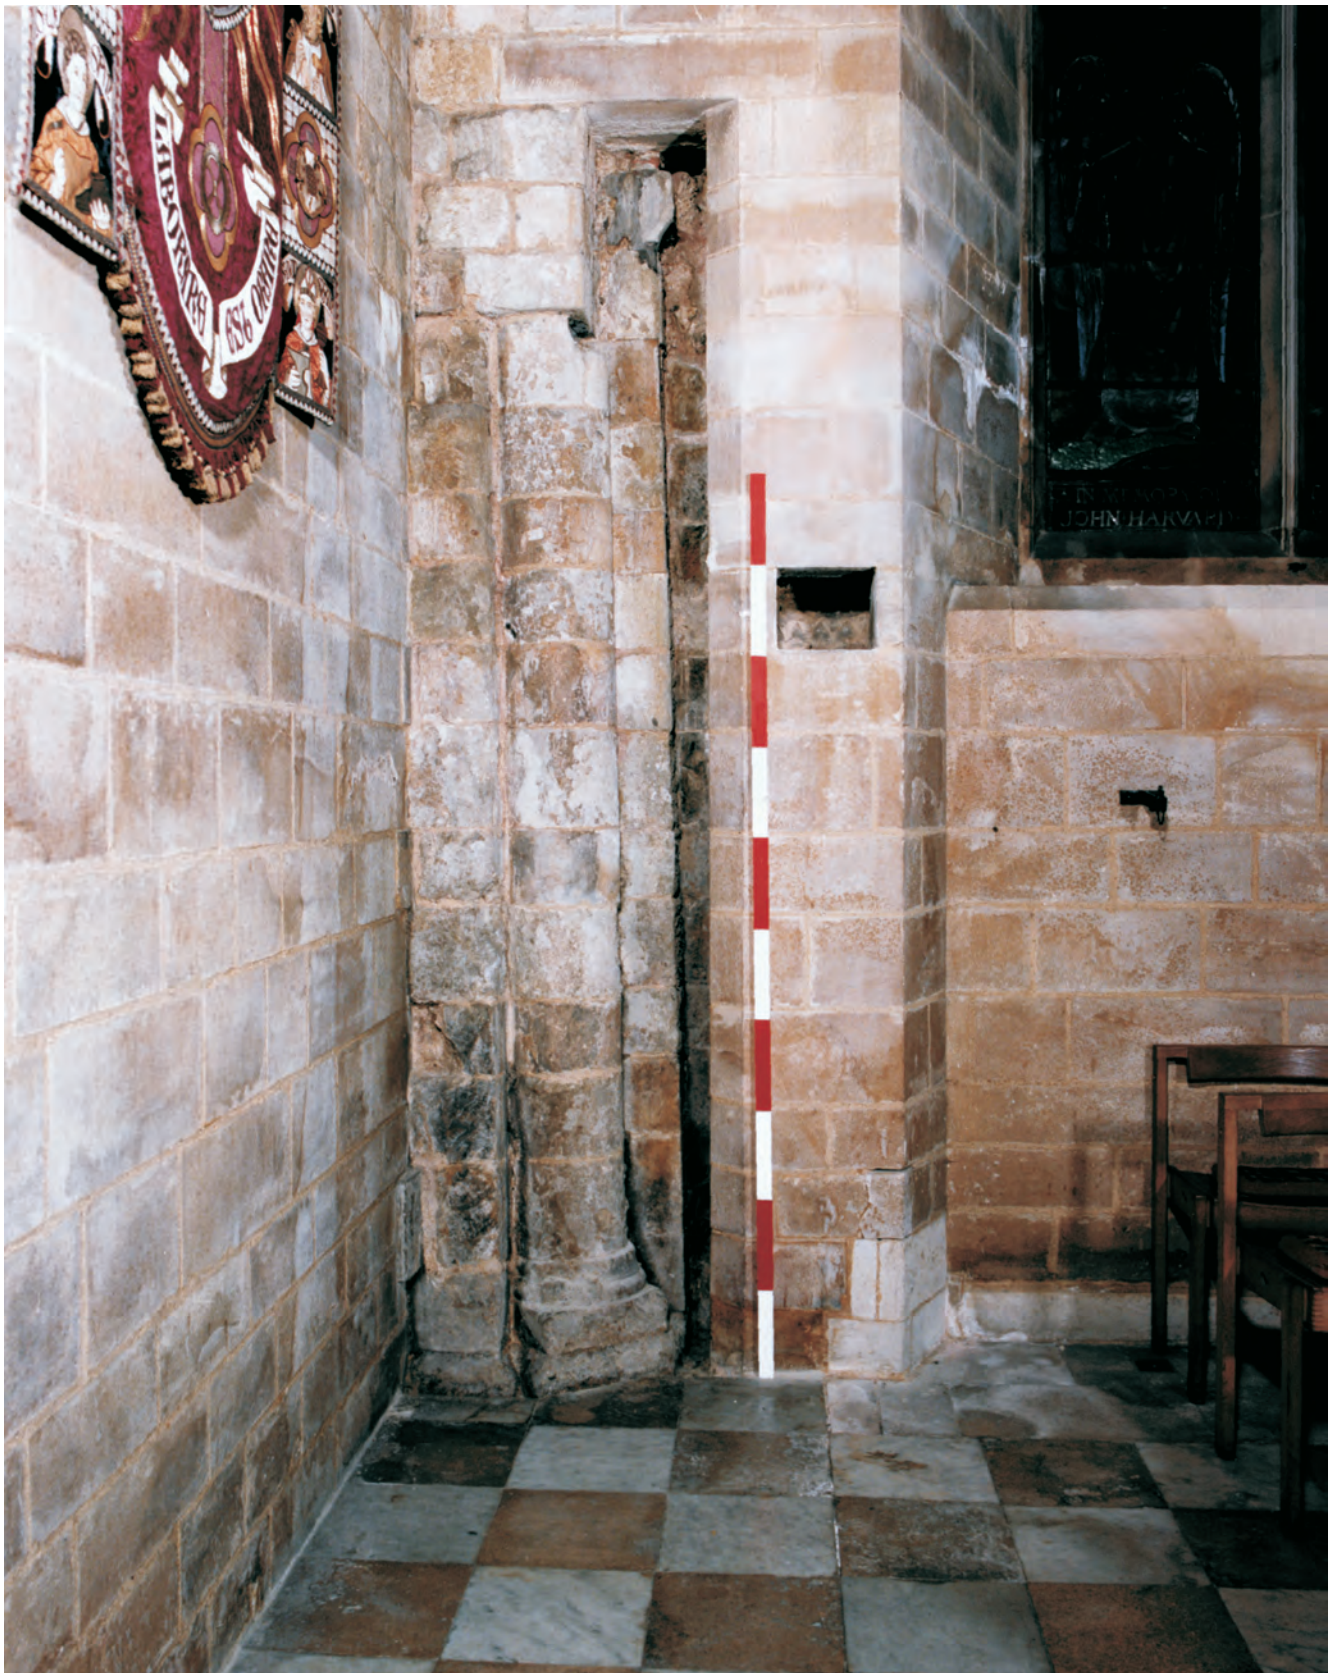
Fig. 49 Nook-shaft in the northeast corner of the northeast transept chapel (2m scale)

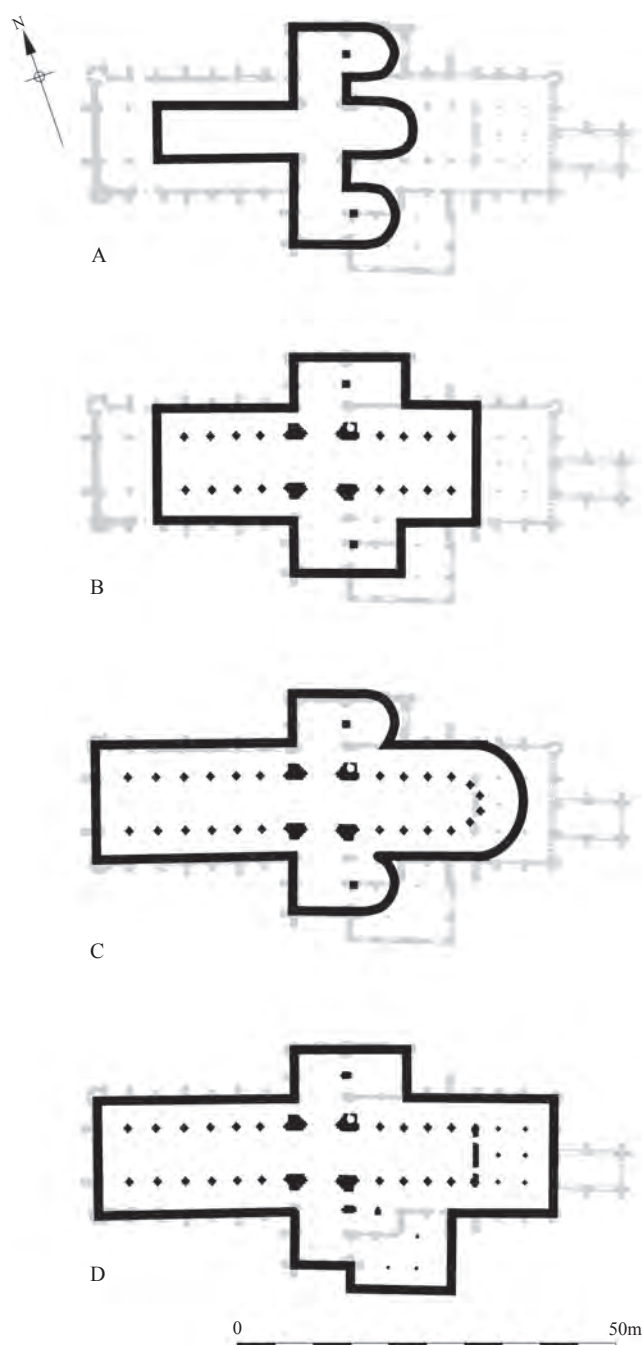
Fig. 74 Proposed phases of development of Southwark Cathedral (scale 1:1,000)

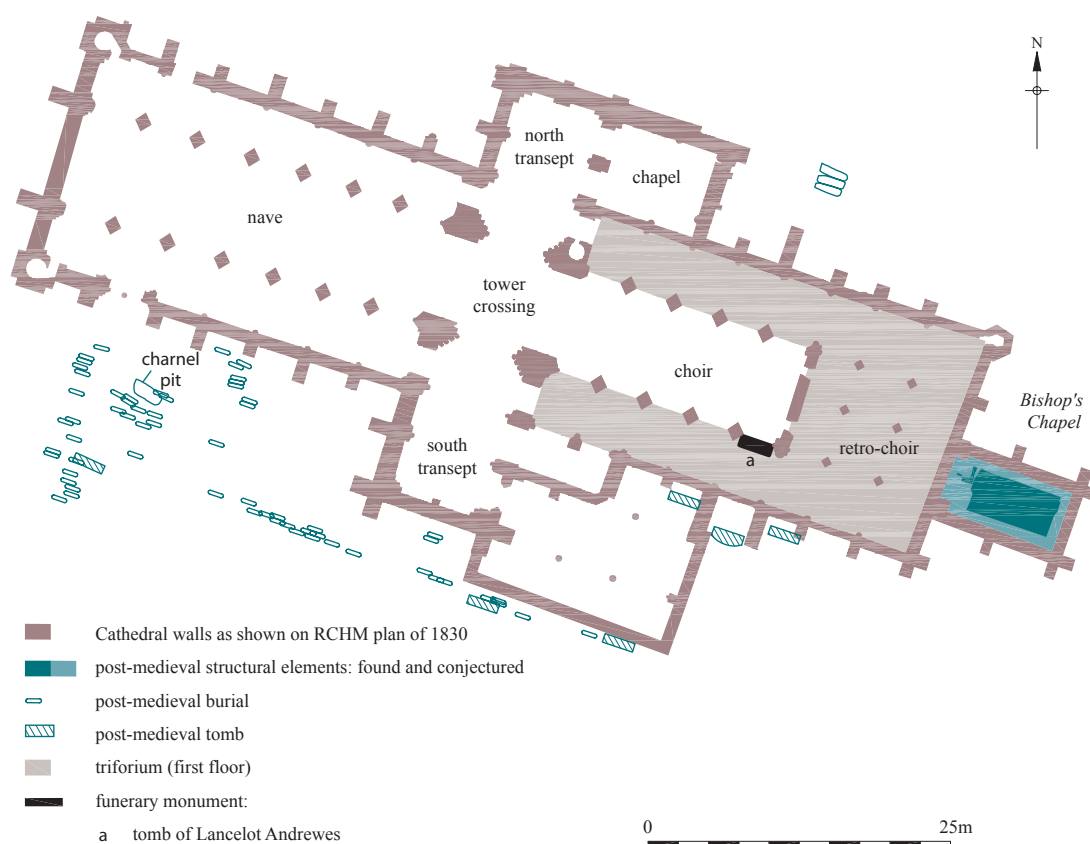
Fig. 76 Elements of the post-Reformation church as revealed through archaeological excavation (scale 1:625)

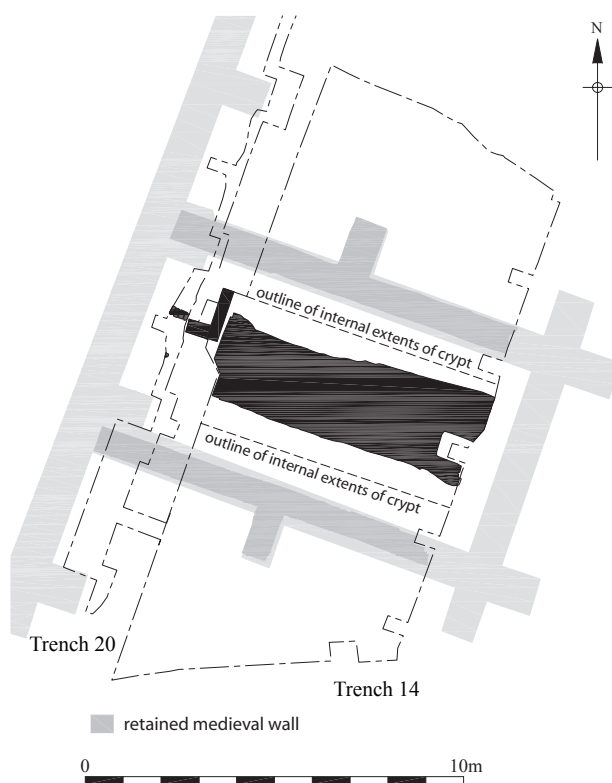
Fig. 81 The conversion of the Lady Chapel to Bishop's Chapel (scale 1:200)

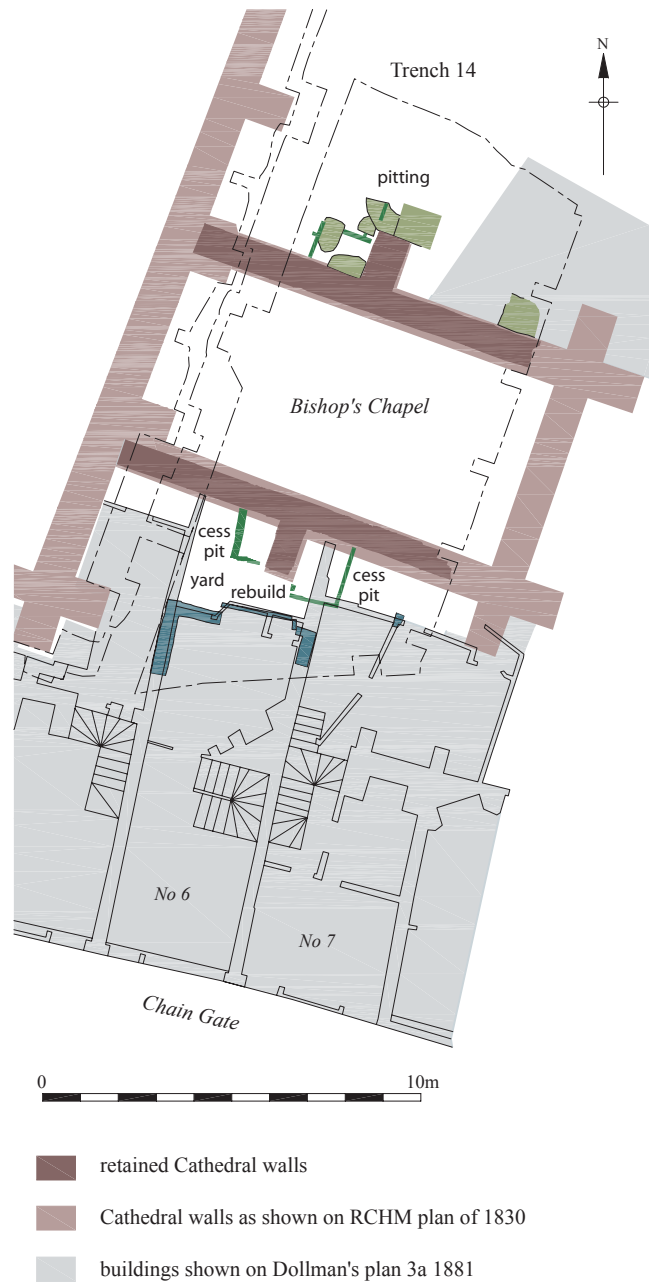
Fig. 100 Detail of excavated Chain Gate buildings and pitting to the north of the Bishop's Chapel (scale 1:200)

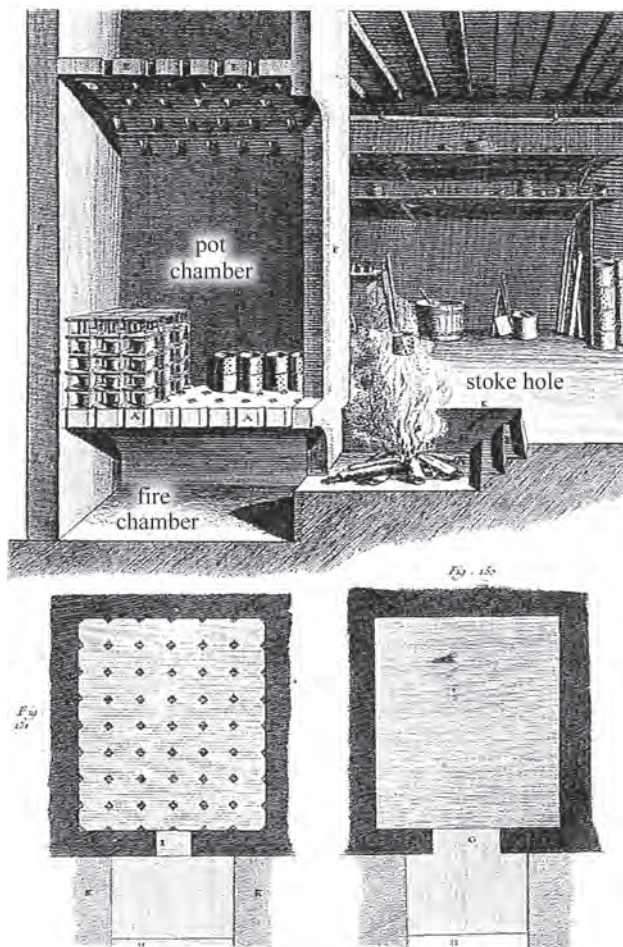
Fig. 107 Plan and cross section of a kiln as illustrated by Diderot

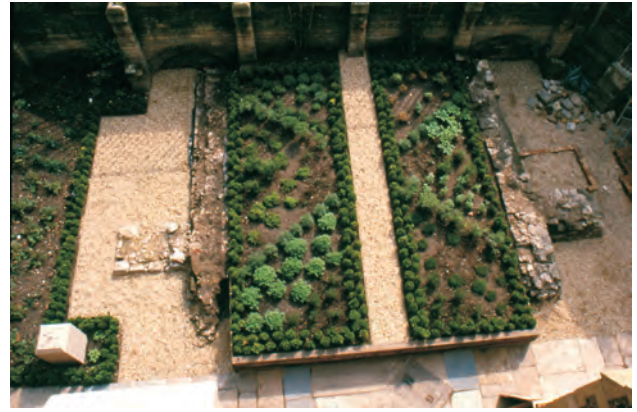
Fig. 126 Foundations of the Lady Chapel preserved in the herb garden to the east of the Cathedral
